Flood Control Project Maintenance

2008 Structure Summary Report

Plumas County

**North Fork Feather River Diversion Channel Drop Structure Drop Structures
No. 1 & 3 Through 7**

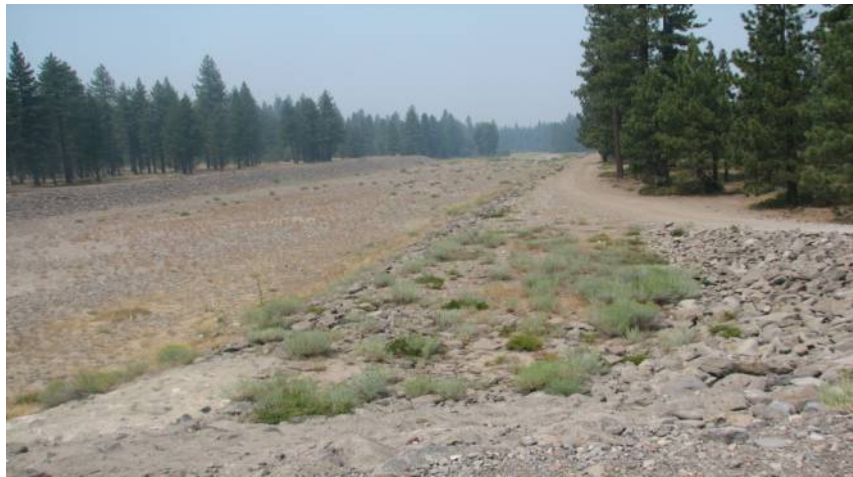
Report Line	1
Location	Water Side
Category	Structures & Concrete Lined Channels
Item	Concrete Surfaces

Rpt Line	Category	Item	Location *	Rating **	Comment	GPS	Photo	Issue
1	Structures & Concrete Lined Channels	Concrete Surfaces	WS	A	4. Vegetation around the structures, the channel banks or in the channel. Acceptable. 5. Comments. Acceptable maintenance.	40.299450 ° -121.261680 °	Y	2
2	Structures & Concrete Lined Channels	Concrete Surfaces	WS	A	1. Condition of grouted rock revetment drop structure. Acceptable. 2. Condition of channel banks upstream and downstream of the drop structures. Acceptable. 3. Accumulation of trash and debris around the structures or in the channel. None	40.272240 ° -121.245540 °	Y	1

View of drop structure 1, looking towards the Feather River.

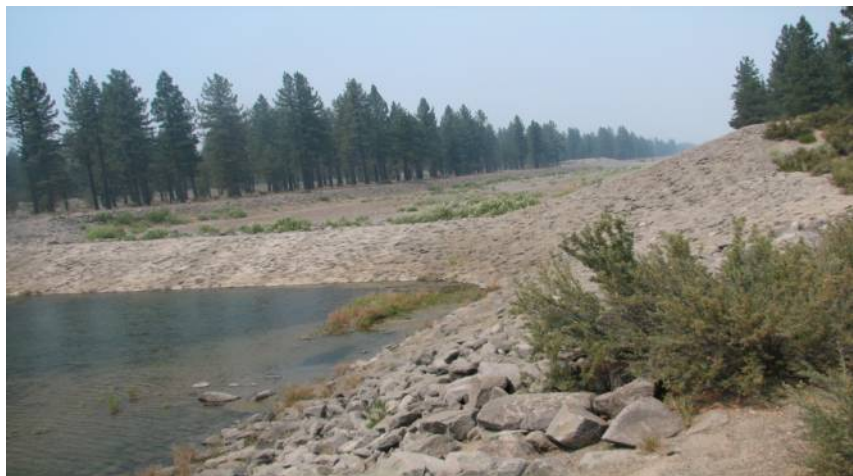
Report Line	2
Location	Water Side
Category	Structures & Concrete Lined Channels
Item	Concrete Surfaces

View of structure 7 looking towards 6 & 5.

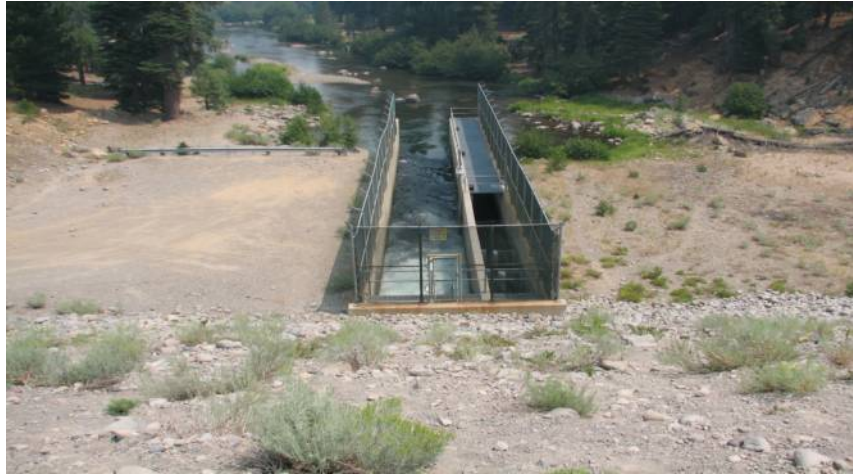
Report Line	1
Location	Water Side
Category	Structures & Concrete Lined Channels
Item	Culverts: Inlets / Outlets

Rpt Line	Category	Item	Location *	Rating **	Comment	GPS	Photo	Issue
1	Structures & Concrete Lined Channels	Culverts: Inlets / Outlets	WS	A	Routinely, one of the three diversion structure conduits is jointly inspected each year with the Corps of Engineers and Plumas County	40.302800 ° -121.262100 °	Y	3
2	Structures & Concrete Lined Channels	Trash Racks	WS	A	Minimal amounts of debris blocking the inlet structure.	40.302800 ° -121.262100 °	Y	1
3	Structures & Concrete Lined Channels	Electric Gate Operators	WS	A	Use of gauging house has been discontinued by Plumas County due to continued vandalism.	40.302800 ° -121.262100 °	Y	4
4	Structures & Concrete Lined Channels	Closure Structures	WS	A	1. The condition of the diversion structure is acceptable. 2. The condition of the deflection structure is acceptable. 3. The condition of the revetments is acceptable. 4. Accumulation of trash and debris around the structure and channel are minimal.	40.302800 ° -121.262100 °	Y	2

The outlet works from the top of the dam.

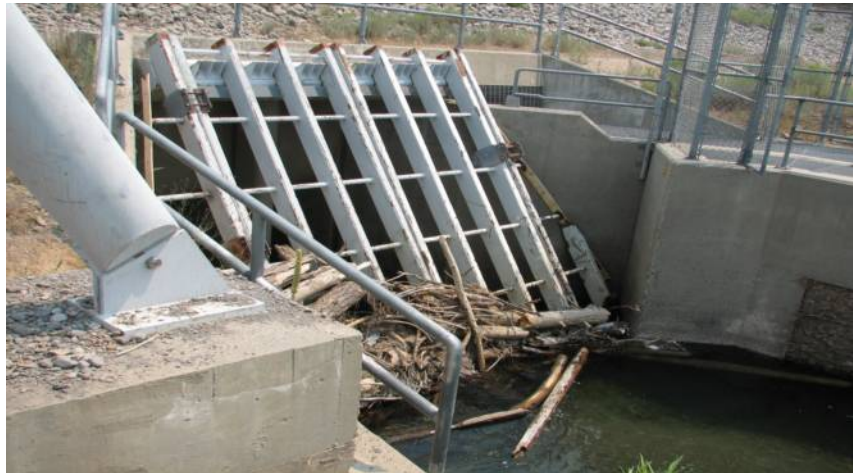
Report Line	2
Location	Water Side
Category	Structures & Concrete Lined Channels
Item	Trash Racks

Minimal amounts of debris blocking the structure inlet.

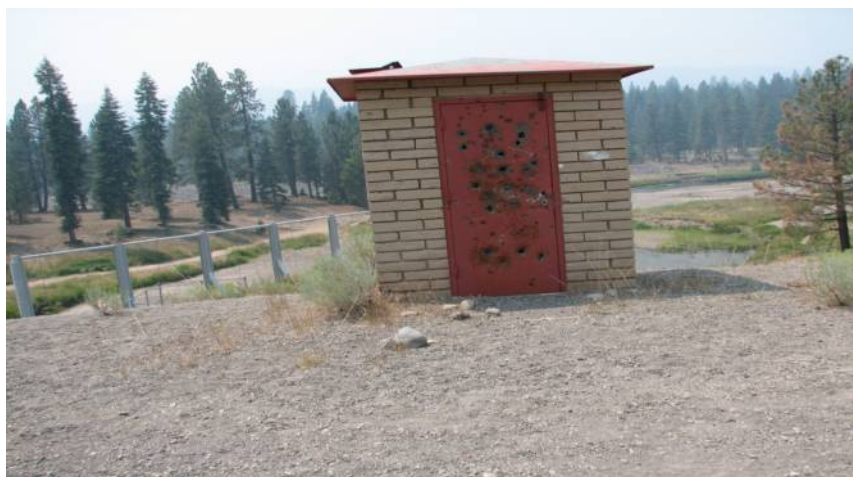
Report Line	3
Location	Water Side
Category	Structures & Concrete Lined Channels
Item	Electric Gate Operators

Gauging house on top of the dam, use discontinued due to vandalism.

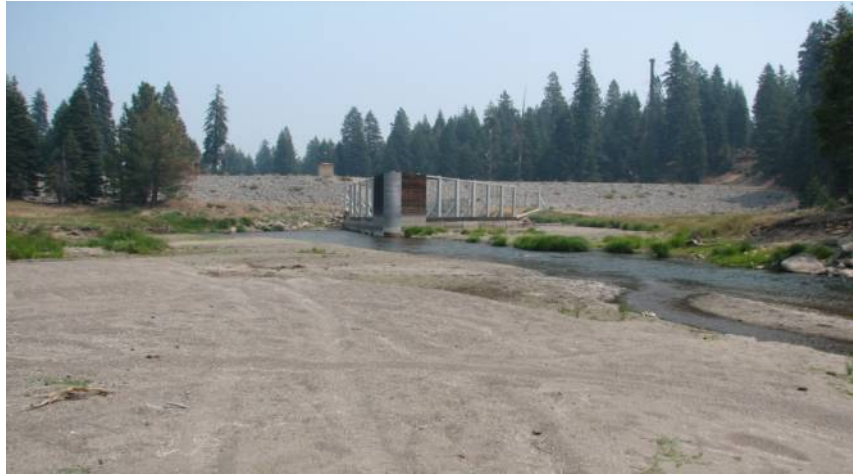
Report Line	4
Location	Water Side
Category	Structures & Concrete Lined Channels
Item	Closure Structures

The upstream side of the diversion structure at the inlet.
